# Pioneering Bismuth deployment for challenging deepwater environment in South America

Didhiti Talapatra, BiSN; Leonardo Pacheco, Petrobras; Marcelo Victor Tomaz, Petrobras; Pedro Goncalves, BiSN; Pedro Mata/Petrobras

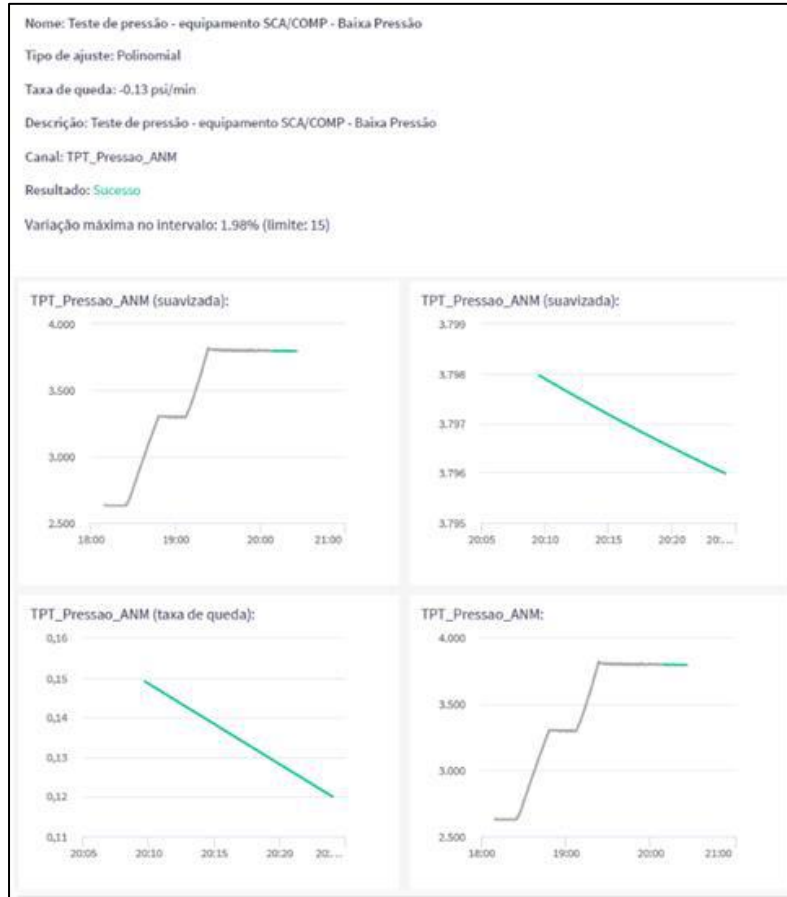
Pressure test with 1,100 psi differential at the top of the plug

- 3.250" OD BiSN Wel-lok Tubing Seal
- First plug set at 3,482 m MD
- Pressure test not successful
- Plug potentially set at wrong depth
- Caliper logs showed irregularities (probably caused by corrosion) on the string from the packer to the screens
- Second plug set at 3,445 m MD in the middle of the Locator sealing area
- **1,100 psi positive test and 300 psi negative test successful**

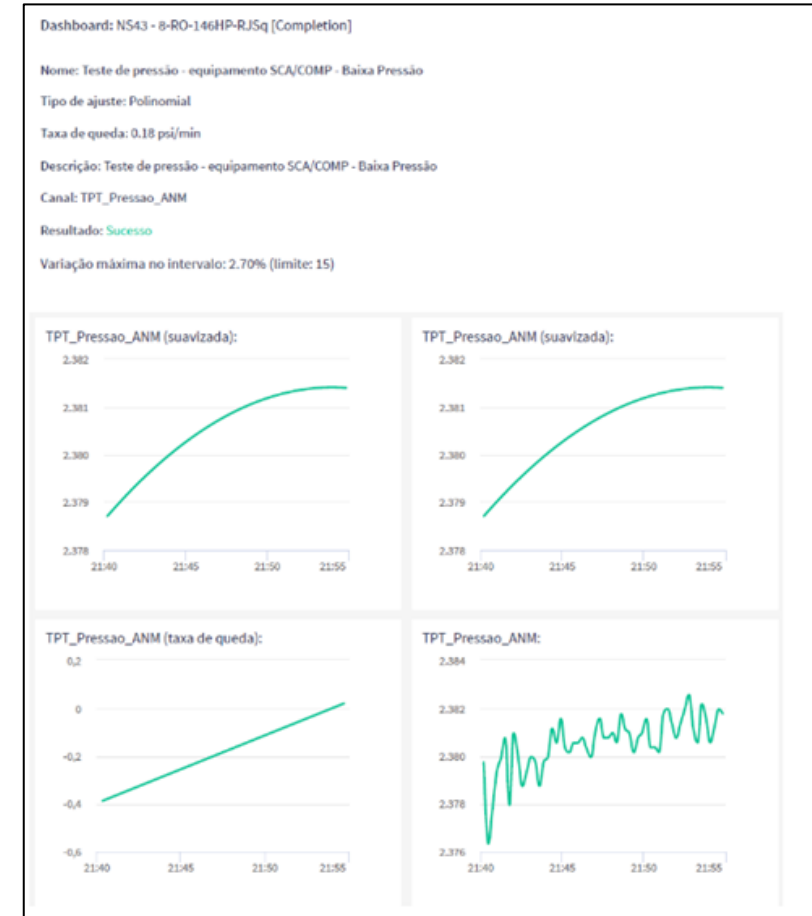
Negative (bottom to top) pressure test at 300 psi
