# **SPE-212879-MS**

## **Complex Operation to Insert Coiled Tubing Through Parted Production Tubing and Regain Pressure Integrity for Plugging and Abandonment**

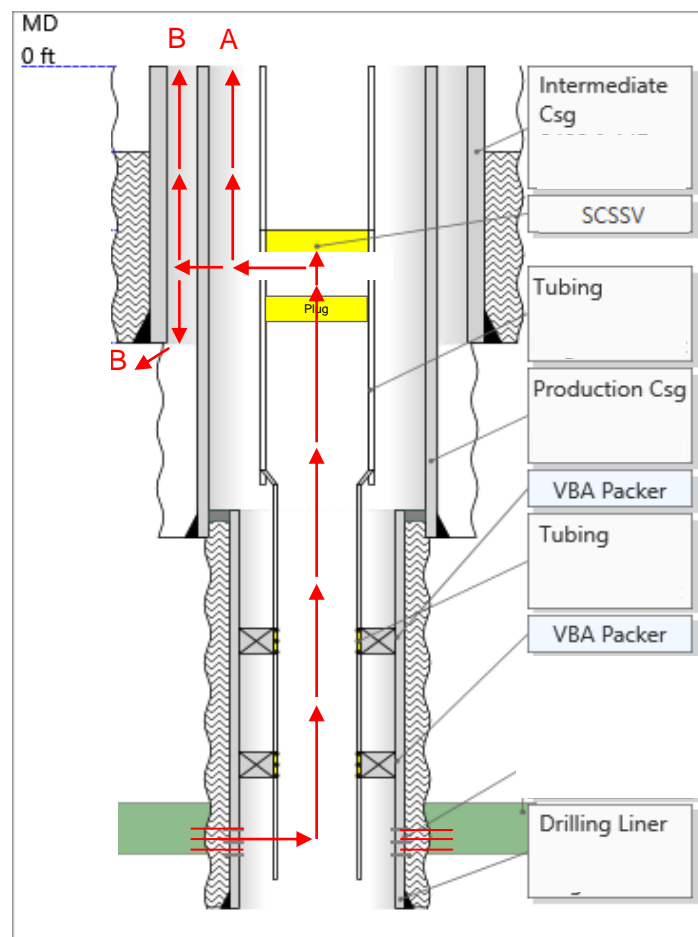
# Well Background

- Well shut-in and still building pressure
- Plug not holding, additional tubing leaks or completion VBA packer leaking
- Known communication between A-annulus and B-annulus
- Single barrier on both the A-annulus and B-annulus (casing hanger) history of leaks/repairs
- Attempt to further mitigate the risk profile by setting an abandonment plug before hurricane season
- Alternatives considered to return well to safe state/in compliance:
  - Zonal isolation via electric line with tractor
  - Permanent abandonment via hydraulic workover unit

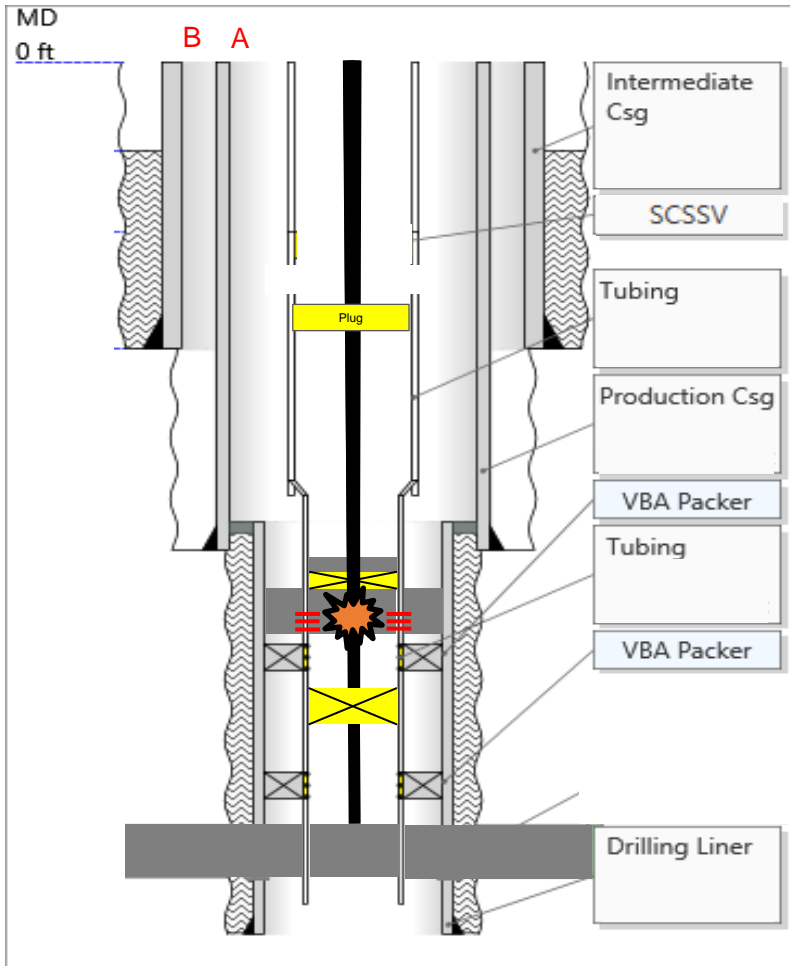
## Plan to Restore Pressure Integrity in the Well      Depth [ft]

E-line pull plug	~4,900 MD
Abandon the producing zone by Bradenhead squeezing cement	~23,500 MD
(Contingency) Test this cement barrier by setting packer	
Perforate the 3 1/2-in. tubing in preparation for balanced plug	~22,350 MD
Set a retainer and place 500-ft balanced plug in A-annulus and tubing	~21,850 MD
Lay in cement on top the retainer	
(Contingency) Test this cement barrier by setting packer

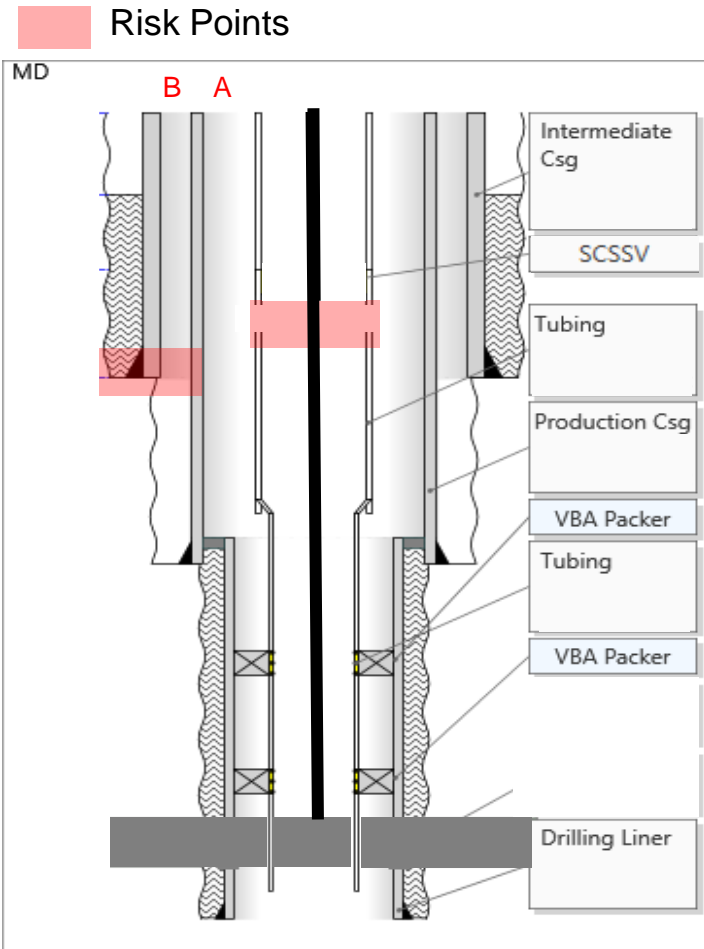
# Challenges

- Unable to enter lower section
- Uncertainty of whether CT entered the tubing or annular space
- Unable to pick back up into the upper section
- Surface pressure limitations due to open 13 3/8-in. shoe and A/B annulus communication
- Pumping cement through CT with fiber-optic cable installed
  - Cable can be buckled, kinked, or ripped off from the connections due to friction drag forces of cement
  - Erosion of fiber-optic cable from solids
  - Cement bonding between fiber-optic cable and CT/connectors
  - Leftover cement can interfere with the other BHAs
  - Pressure ports on tool can become plugged

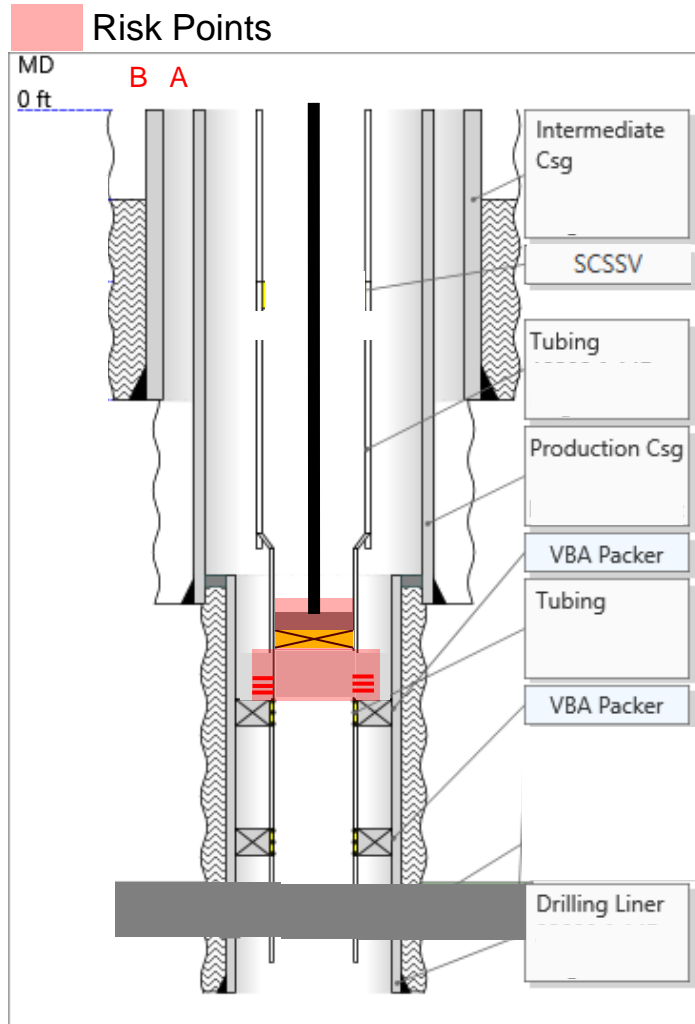
# Challenges

## Perforating the 3½-in. production tubing

- Depth control for perforating (between VBA packer and downhole pressure gauge)
- Poor indications of guns firing
- Risk of retrieving live guns through parted production tubing
- CT becoming stuck with undetonated charges
- Orienting the guns with knuckle joints and bow spring

## Setting retainer, placing 500-ft balanced plug

- Retainer element damaged by tubing part
- Not able to confirm retainer is fully set due to pressure communication at the part below and above the retainer
- If not fully set, cement could go around retainer onto backside of CT
- Retainer prematurely setting in production tubing

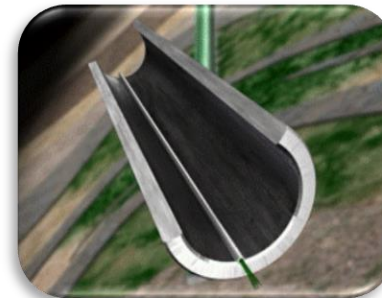
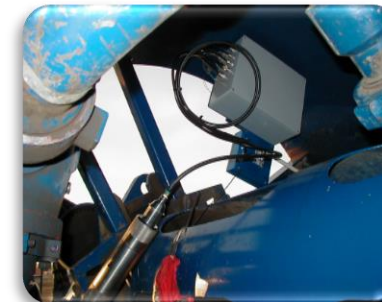
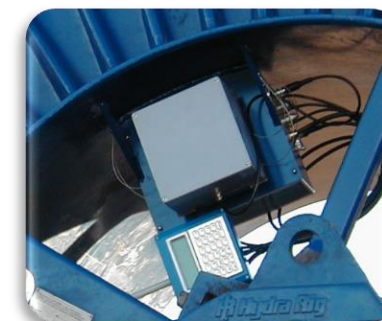
## Resolves Common CT Uncertainties

- Determining an accurate depth of the tool end
- Monitoring and controlling downhole pressure
- Identifying if wellbore is being loaded with sand or debris
- Monitoring differential pressure across the tool
- Verifying perforating tools are operating effectively

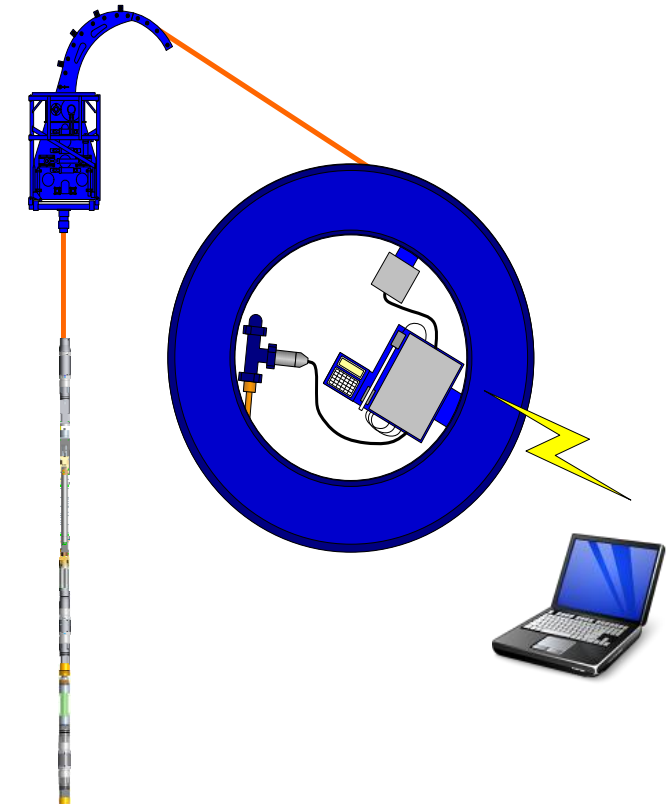
## Real-Time CT Bottomhole Assembly (BHA)

- Pressure, temperature, and casing collar locator (CCL)
- Real-time fiber optic telemetry

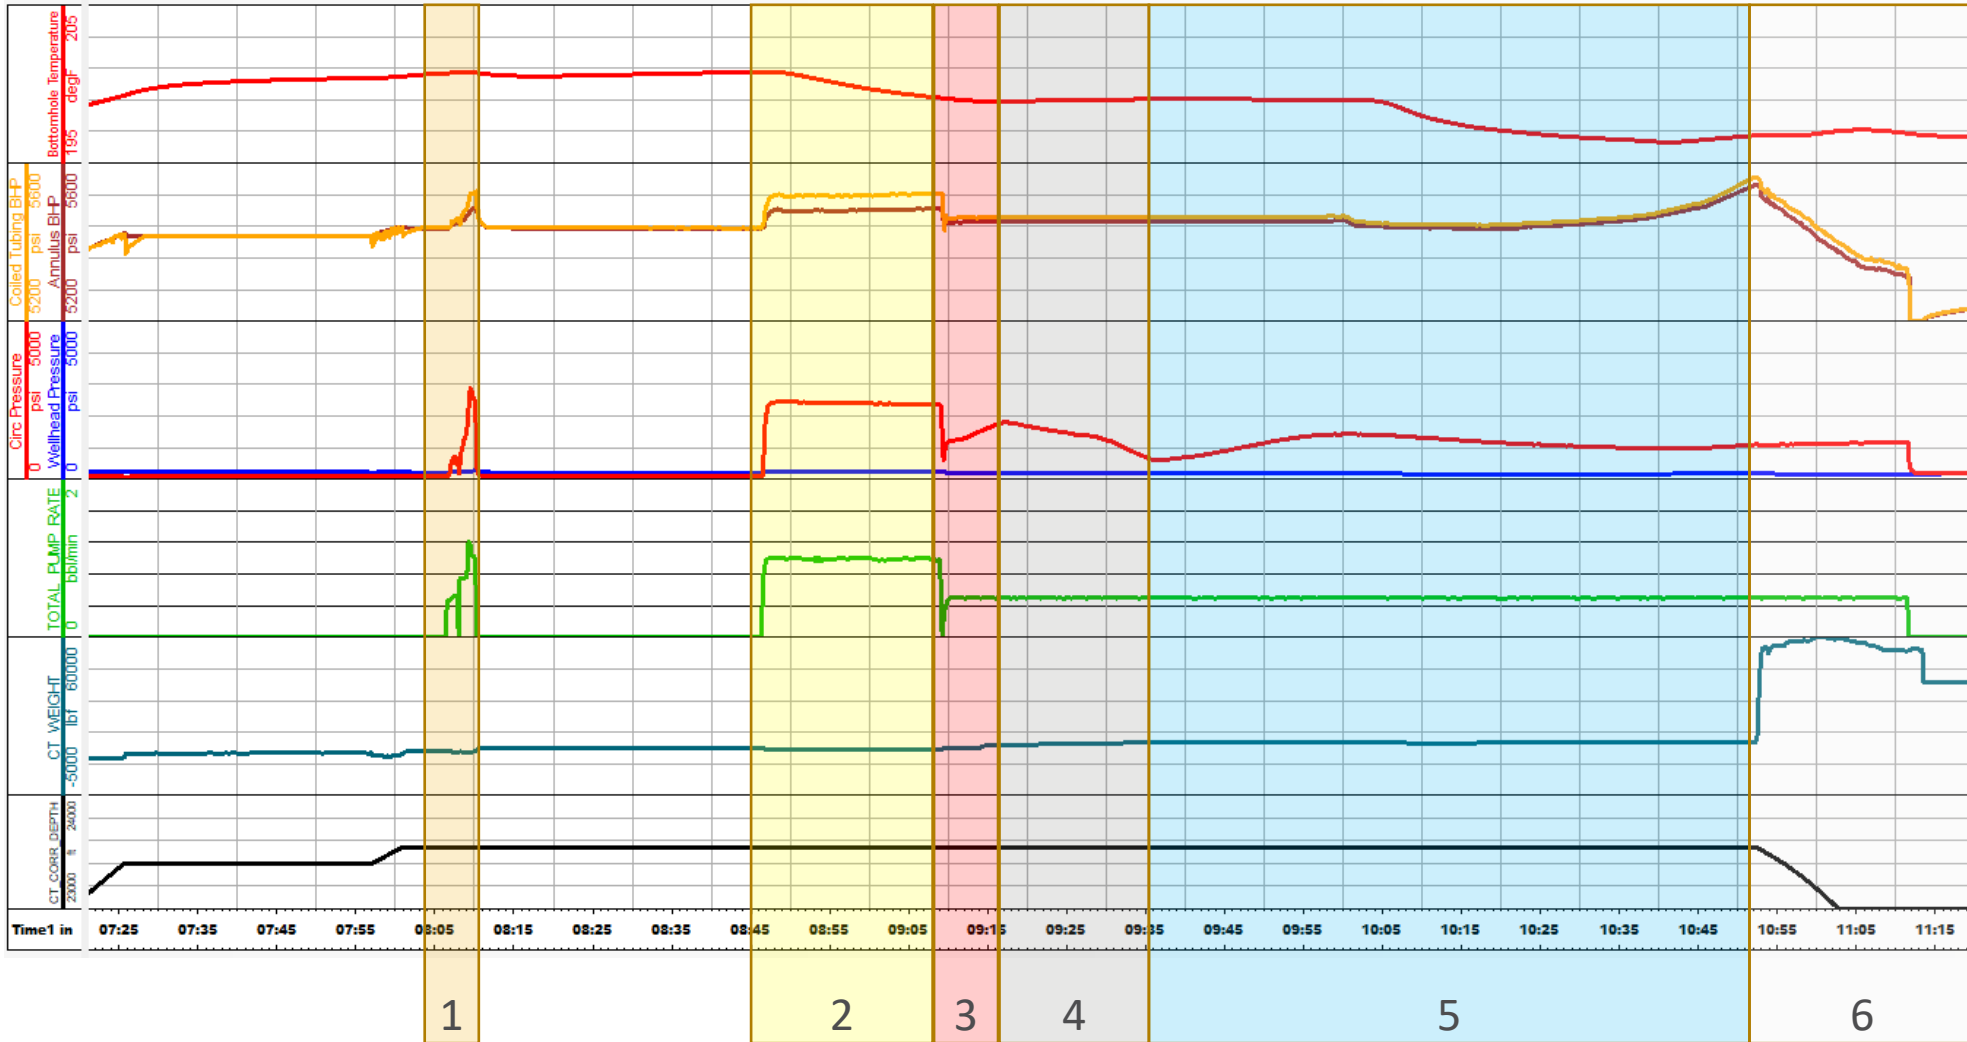
# Run 1 - Isolate the Producing Zone

1. Injection Test
2. Lead Spacer
3. Cement
4. Tail Spacer
5. Displacement
6. Lay in Cement

Rate (bbl/min)	Pressure (psi)
0.5	233
0.75	243
1.0	272

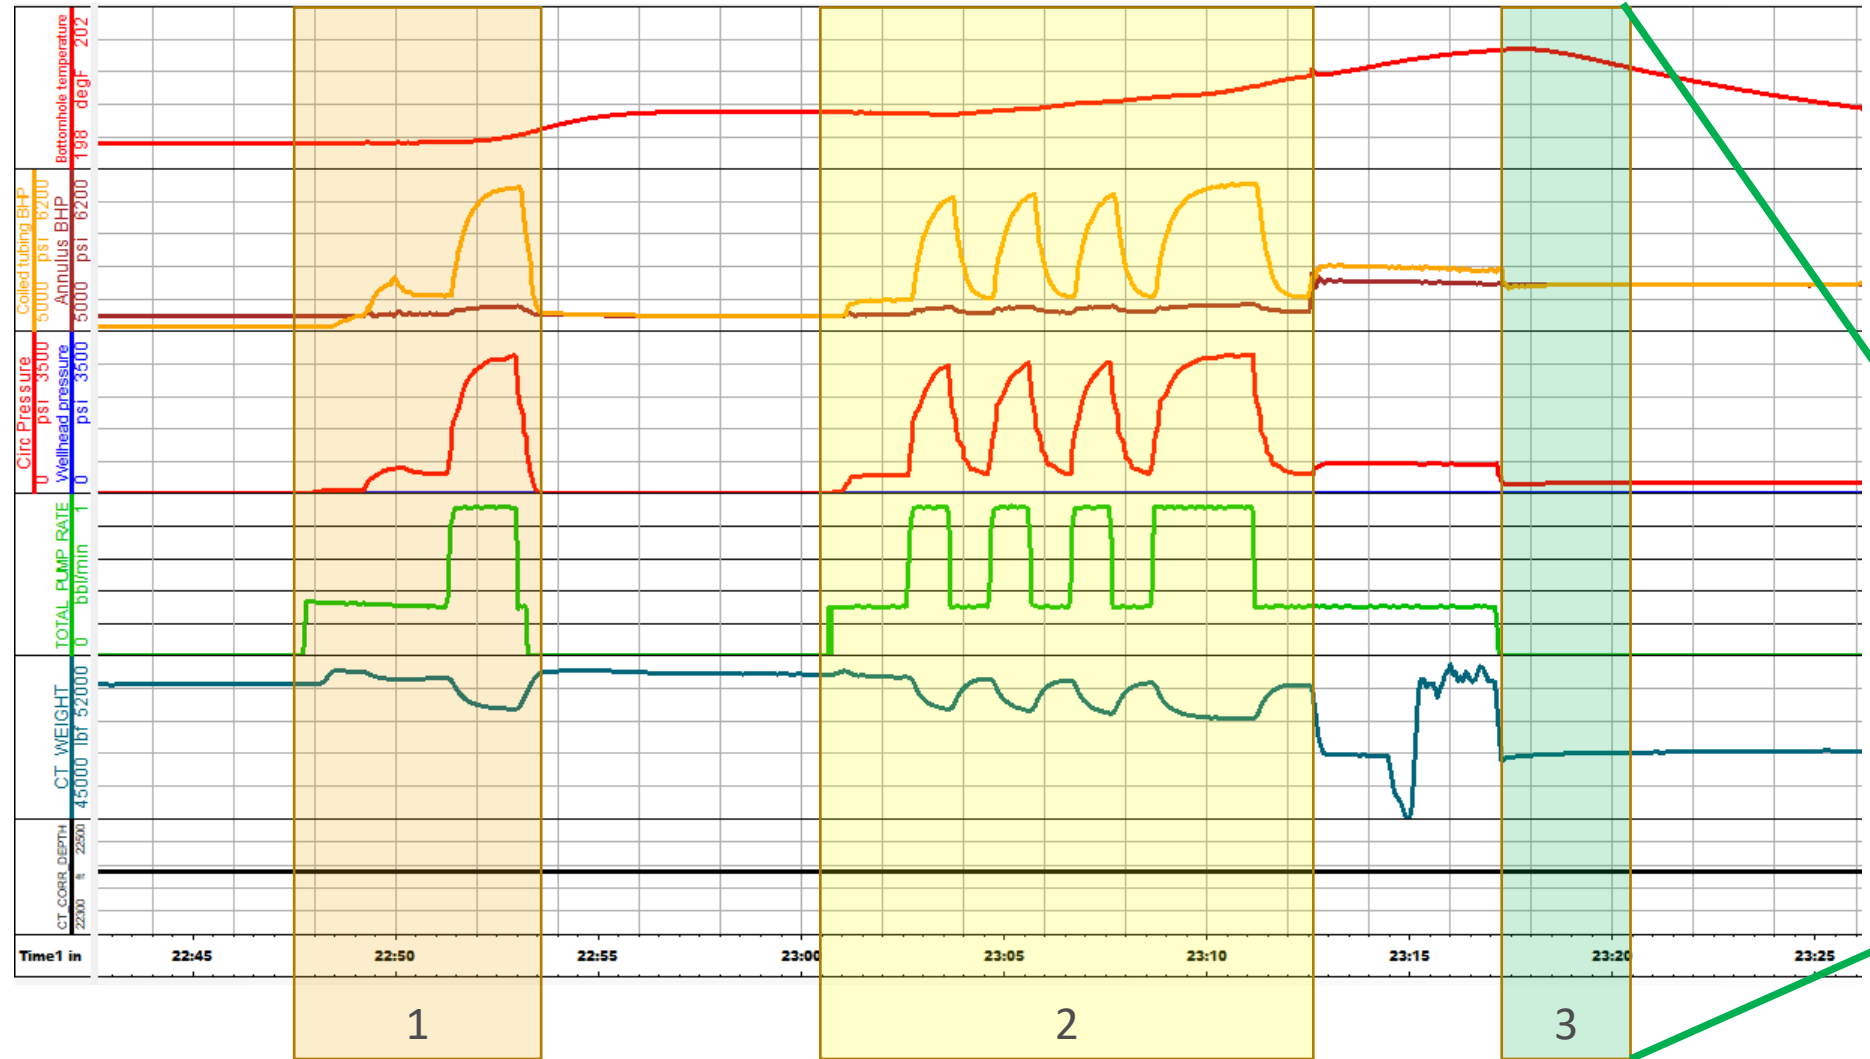
# Run 2 – Perforate 3 1/2-in. Tubing

- 1. Training Pulses
- 2. Command Sequence
- 3. Guns Fire

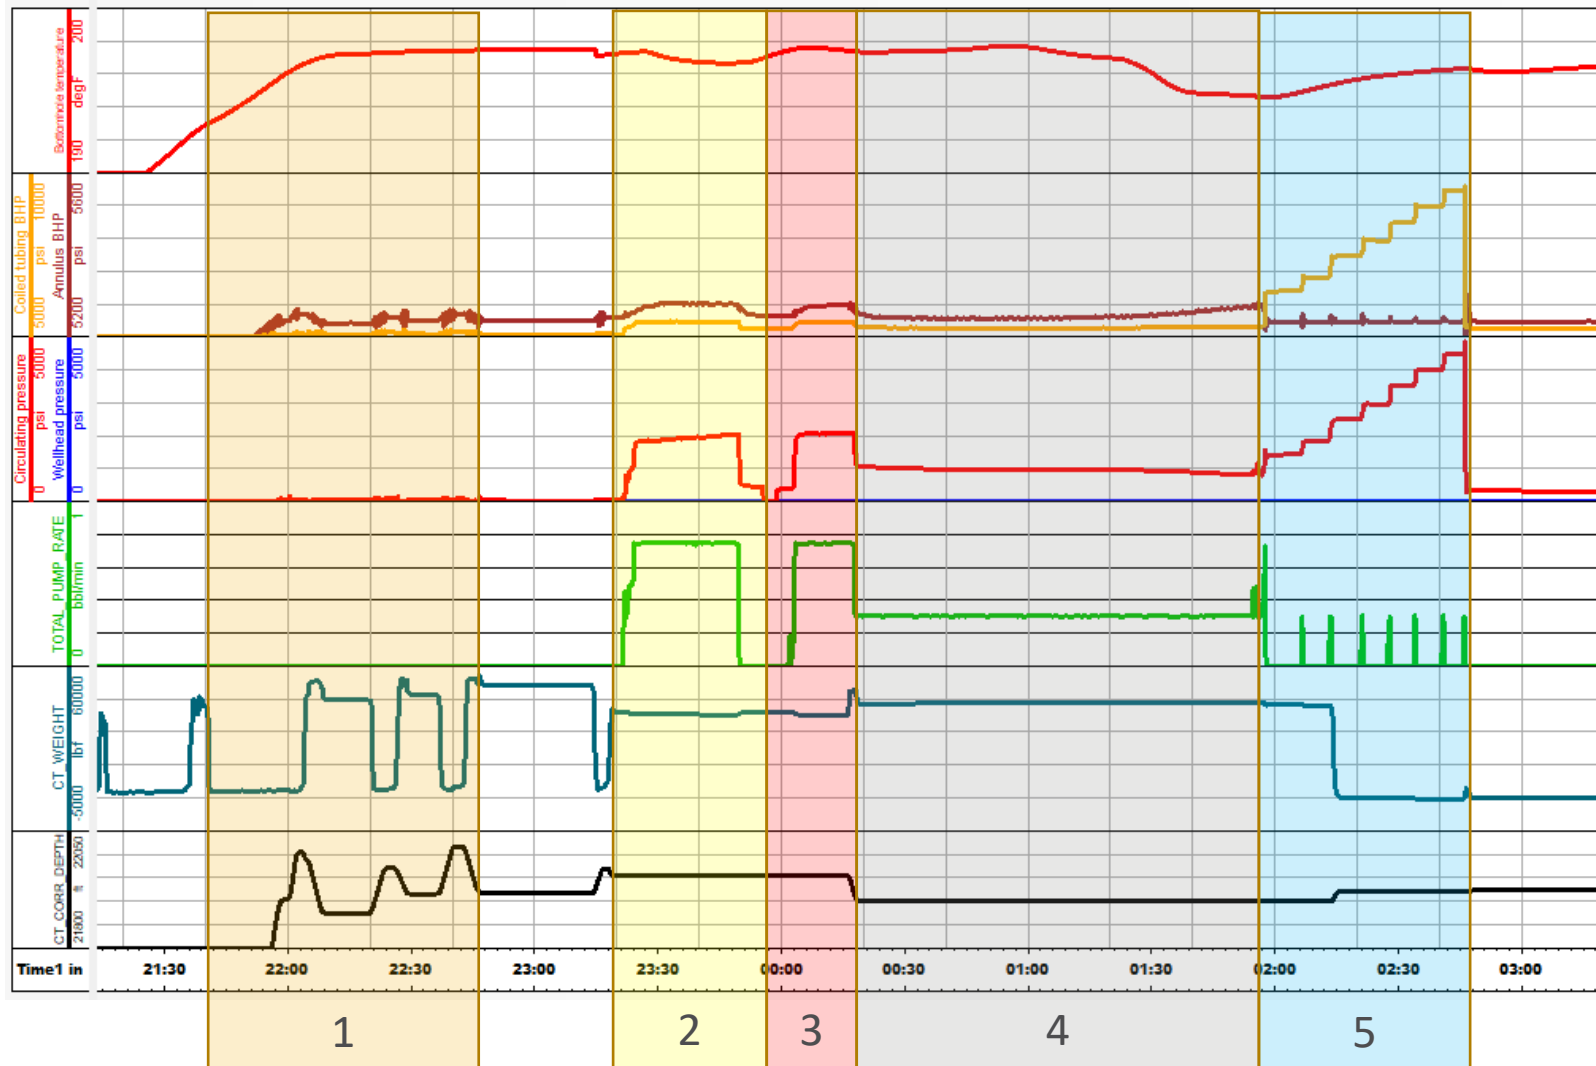
# Run 3 – Set Retainer, Pump 500-ft Balanced Plug

- 1. Depth Correlation
- 2. Lead Spacer
- 3. Ball Dropped
- 4. Ball Displacement
- 5. Seating Retainer

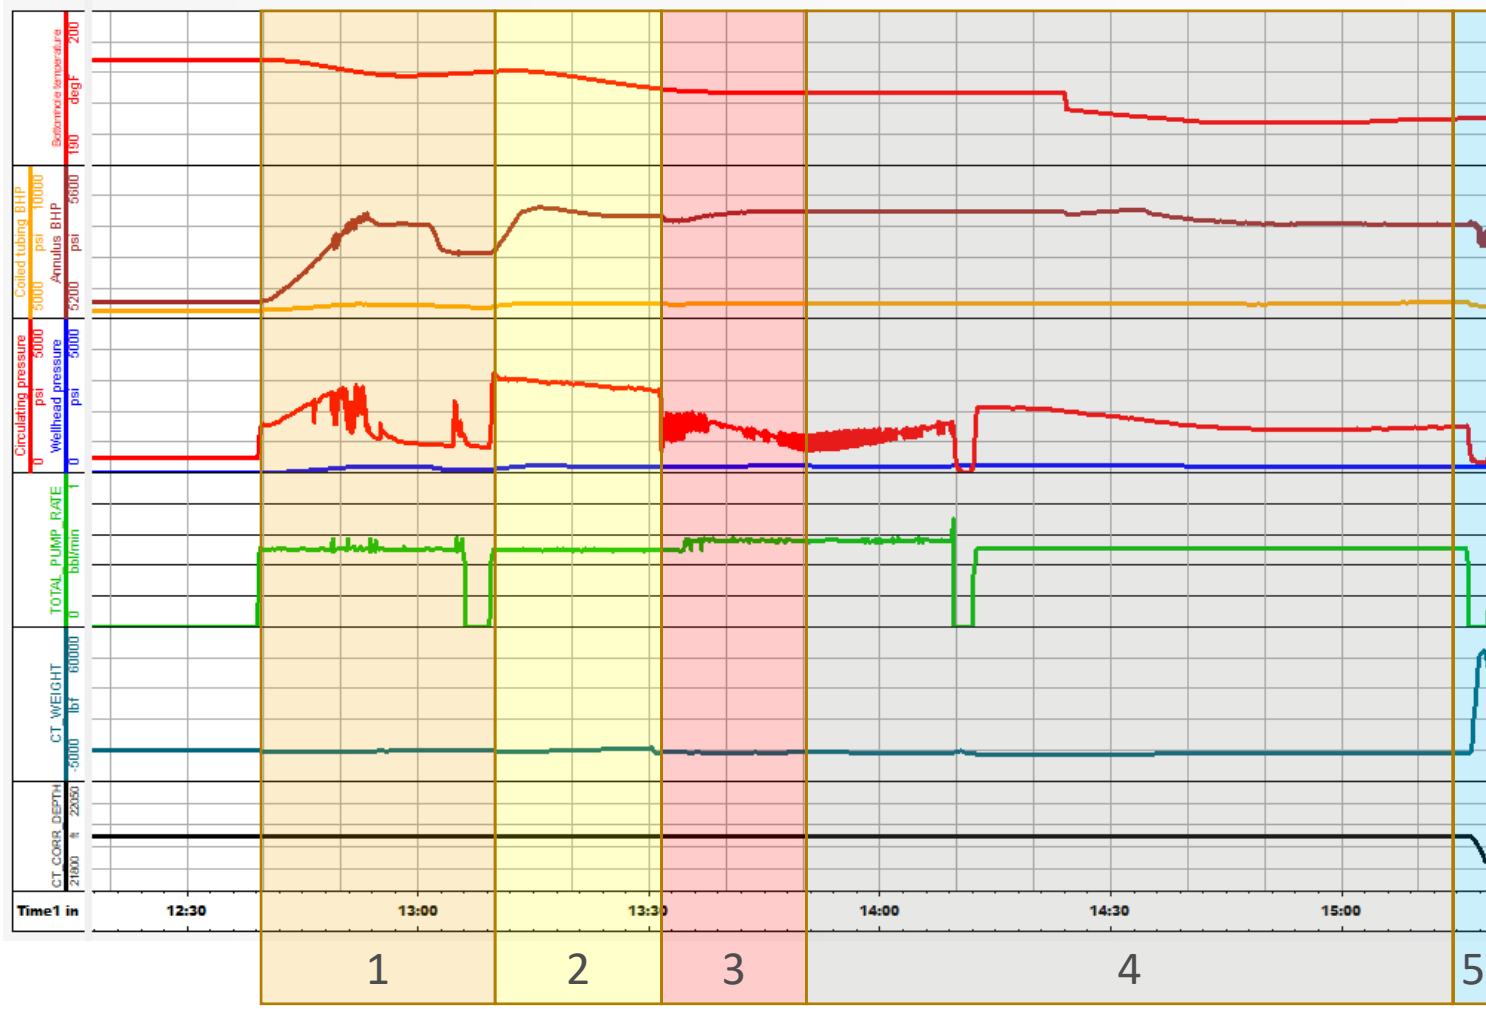
# Run 3 – Set Retainer, Pump 500-ft Balanced Plug

| 1. Lead Spacer |
| 2. Cement |
| 3. Tail Spacer |
| 4. Displace and Set Cement |
| 5. Disconnecting From Retainer |
