# Improving Late Life Well Integrity through Sustained Casing Pressure Remediation

Thore Andre Stokkeland Archer – the well company

Alex Lucas and Michael Cowling Total E&P Danmark

SPE Aberdeen Well Late Life And Well Abandonment Conference  
Aberdeen 27th June 2018

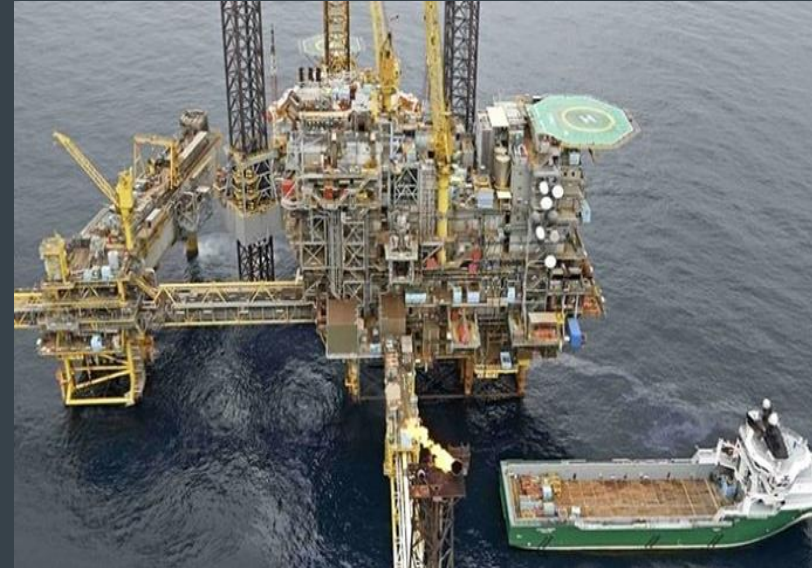
Sustained Casing Pressure (SCP) is a typical Brownfield well integrity issue that requires close monitoring and management. Where SCP is formation-driven, typically the annular cement isolation behind production casing has failed and cannot be easily remediated by simply replacing tubing or installing an additional tieback string

However, it is not uncommon for ca. 15-20% of platform wells to exhibit this phenomenon, which represents a significant challenge to the industry.

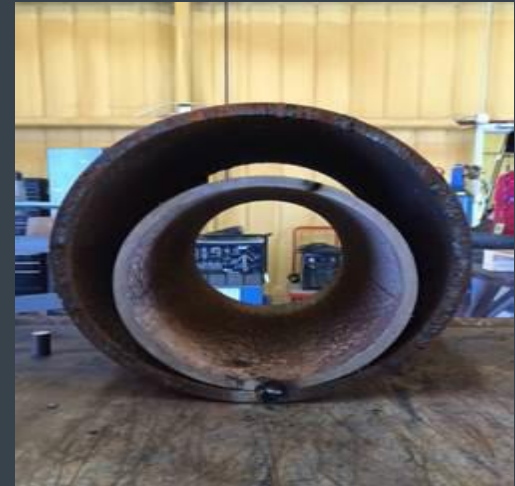
### Single Casing Perforation Gun System

- Specially designed to perforate 9 5/8 40# without damaging 13 3/8 68#
- 5,5 Inch centralized TCP Gun System
- Produces 0,44 Inch average EHD  
Optimized for this specific Perforate, Wash and Cement System.
- Successfully tested and validated
- Field Proven

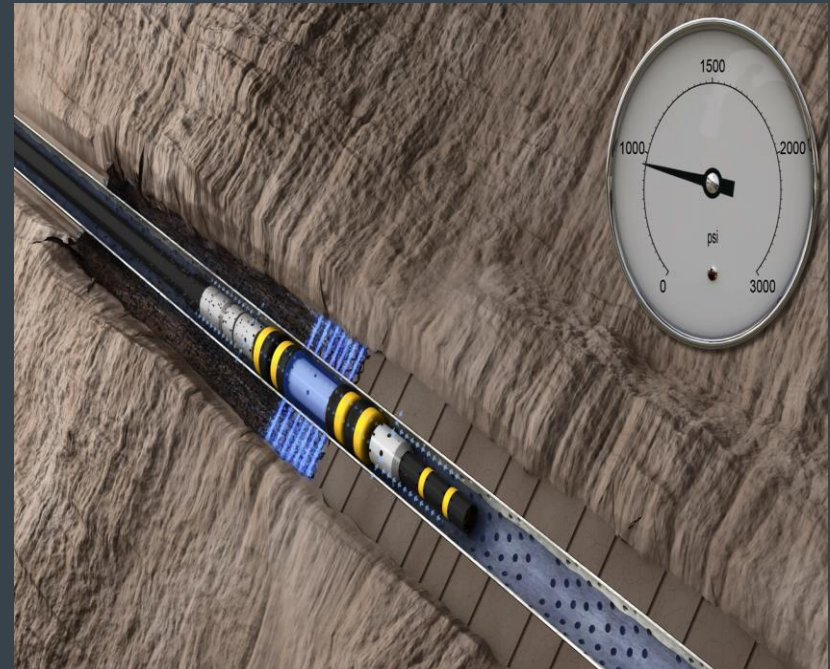
### Closed System Cup Type Perforate, Wash and Cement Tool

- Efficient Washing with continuous hydraulic indication of performance with standpipe pressure as main performance indicator.
- Focus all the mudpump horsepower within a limit area at the time while moving. Provides excellent annular velocity
- Heavy Duty Cup System blocking the ability for the fluid to bypass up DP x Casing Annulus
- Field Proven in over 120 + runs globally

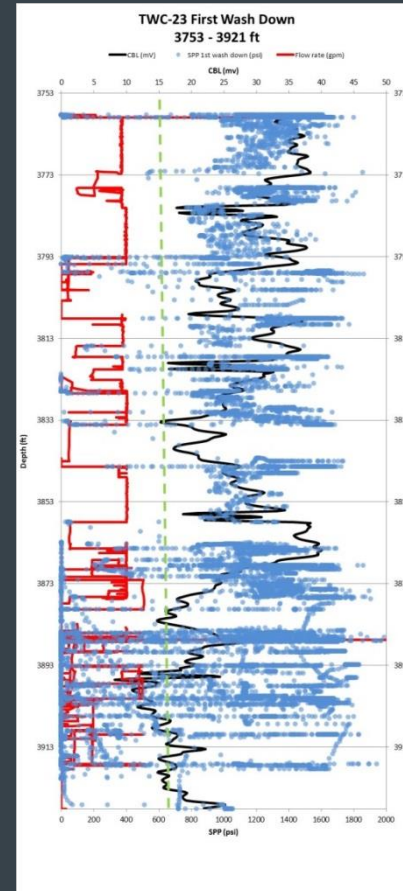
The perforations were initially planned to be washed up and down, but an additional third pass with higher flowrates was performed.

Positive indications were achieved that a clear hydraulic flow path was established to enable cementation.

The indications was a clear declined standpipe pressure across the perforations, in addition to a lot of debris.

A total of 445 kg of debris, mostly consisting of cement was recovered at the shakers.

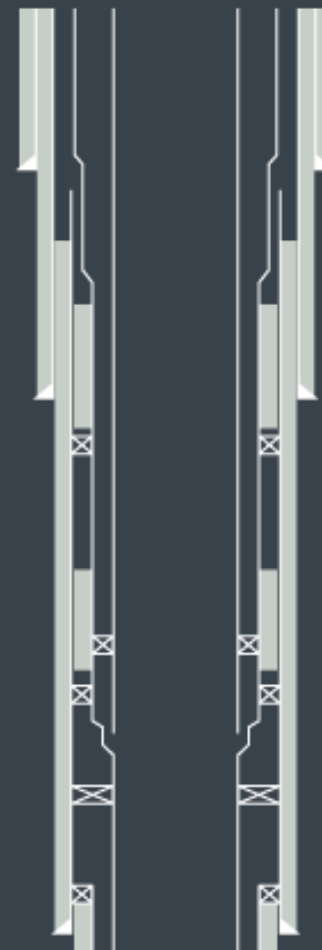
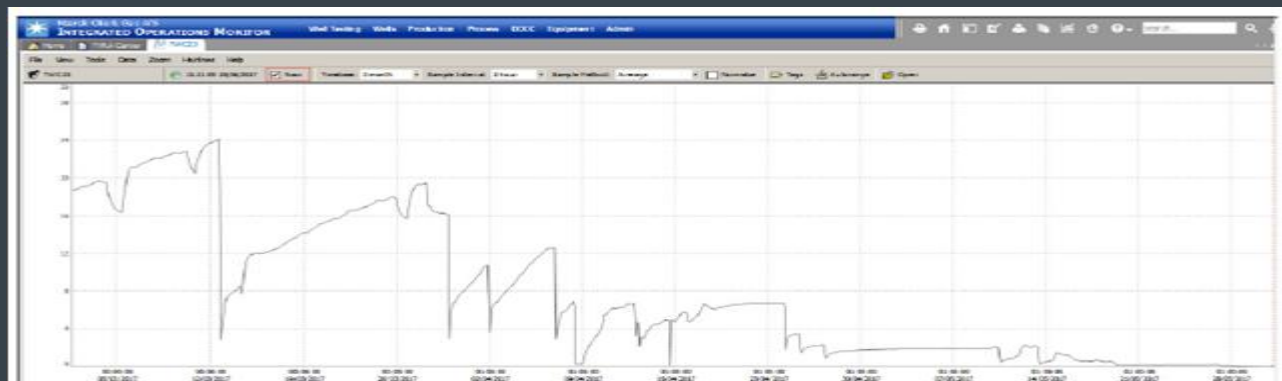
After the cement had set up the B-section pressure build had adequately reduced to satisfy the acceptance criteria.

After a monitoring period of 22 days the rig skidded back over the well and the B-section pressure was stable at close to zero psi.

The cement was drilled out and logged showing improved quality across the majority of the remediated area.

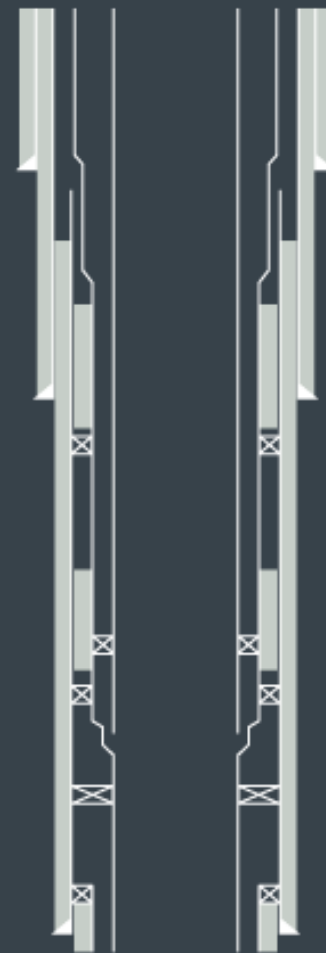
After 22 days the RBP was successfully retrieved and cement drilled out. The formseal and the deepset RBP was also successfully retrieved

The 7" x 7-5/8" x 9-5/8" casing tie-back was installed, the well was re-completed with a new upper completion and when the well was handed back to Production 40 days after remedial cementing was performed, the B-section pressure was stable at 0 psi
